## WORK ORDER #: WO135893

## EMERGENCY SERVICE

<b>Created</b>	11/6/2024 8:09 AM	<b>Last Updated</b>	11/6/2024 3:25 PM
<b>Type</b>	Local Service	<b>Priority</b>	
<b>Status</b>	Completed	<b>Last Visit Date</b>	11/7/2024
<b>Next Step</b>	No Action Required – internal	<b>Field Specialist</b>	Morgan
<b>Primary Incident Type</b>	Door Service	<b>Signed By</b>	Takura
<b>Customer Asset</b>		<b>P.O #</b>	SYW5499312
<b>Scope of Work</b>	Main Dock Door - Door chain hooked on something and door no longer functioning electrically.

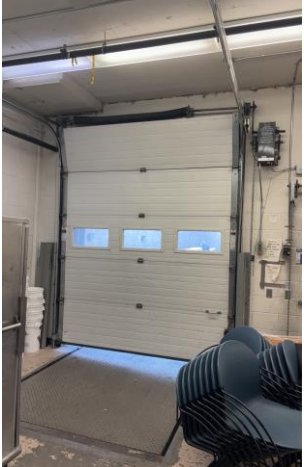
Details	Content
<p><b>Created On:</b> 11/6/2024 10:34 AM</p> <p><b>Created By:</b> Morgan</p>	<p>Loading dock door. 8'2" x 10' , OHD591.</p>

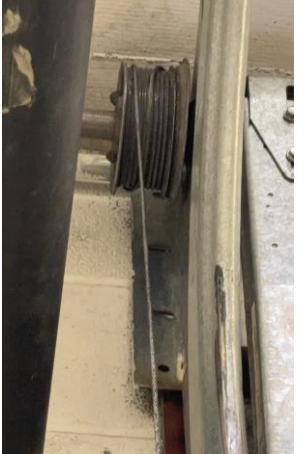
A photograph showing a white overhead door (OHD) in a loading dock. The door is partially open, revealing a blue mat on the floor. To the right, there are stacks of blue chairs. The door has three small windows near the bottom.
<p><b>Created On:</b> 11/6/2024 10:35 AM</p> <p><b>Created By:</b> Morgan</p>	<p>Cable has come off the left side drum.</p>

<p><b>Created On:</b> 11/6/2024 11:10 AM</p> <p><b>Created By:</b> Morgan</p>	<p>Put the left side cable back onto the drum.</p>

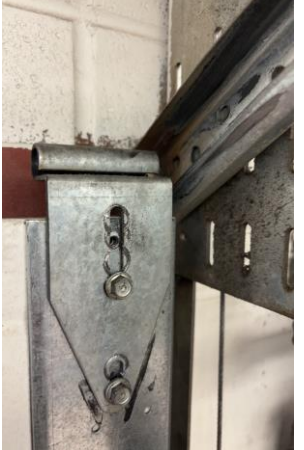
A close-up photograph of a metal drum and cable assembly. The cable is coiled around the drum, and there is some visible wear or damage to the hardware.
<p><b>Created On:</b> 11/6/2024 11:00 AM</p> <p><b>Created By:</b> Morgan</p>	<p>Loading dock door has a missing top 2" roller.</p>

<p><b>Created On:</b> 11/6/2024 11:11 AM</p> <p><b>Created By:</b> Morgan</p>	<p>Installed new 2" long stem roller in the right side top fixture.</p>
