WORK ORDER #: WO90019

EMERGENCY SERVICE

Created	1/24/2022 12:02 PM	Last Updated	1/26/2022 4:02 PM
Type	Local Service	Priority	
Status	Completed	Last Visit Date	1/24/2022
Next Step	No Action Required – internal	Field Specialist	Ed
Primary Incident Type	Door Service	Signed By	
Customer Asset		P.O #	
Scope of Work	Building A, Door 28 won't close.

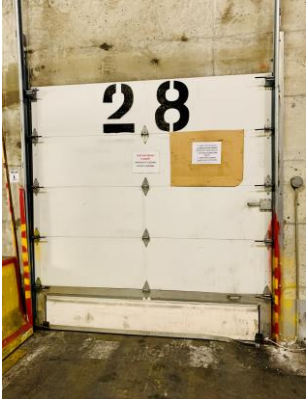
A photograph of a white industrial door with the number '28' printed on it. The door is slightly ajar, and the surrounding area shows some wear and tear on the wall and floor.
<p>Created On: 1/24/2022 4:13 PM</p> <p>Created By: Ed</p>	<p>Photo of Door 28.</p>

Details	Content
<p>Created On: 1/24/2022 4:13 PM</p> <p>Created By: Ed</p>	<p>Arrived on site and inspected door. Found door open and unable to close; bent right track, jamb brackets and steel angle was loose from wall. Removed right track and straightened with hammer. Removed broken anchor bolts from angle and installed 3 new wedge anchors. Reinstalled right track.</p>

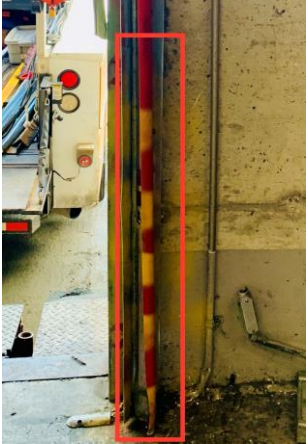
A close-up photograph of the vertical track of the door. A red rectangular box highlights the track area, showing some damage and the installation of new components.
<p>Created On: 1/24/2022 4:13 PM</p> <p>Created By: Ed</p>	<p>Second photo of Door 28.</p>

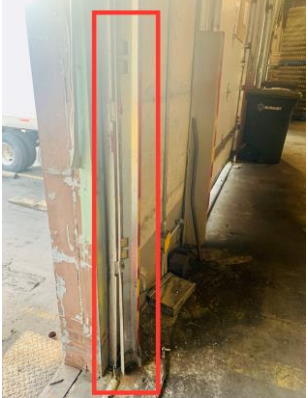
Another close-up photograph of the vertical track of the door, similar to the previous one, with a red rectangular box highlighting the track area.

<p>Created On: 1/24/2022 5:42 PM</p> <p>Created By: Ed</p>	<p>Tested door. Door is working condition again.</p>
