**Weather Seal for Rolling Steel Door**  
Food Manufacturing Facility

Cobourg, ON

**Project Overview**

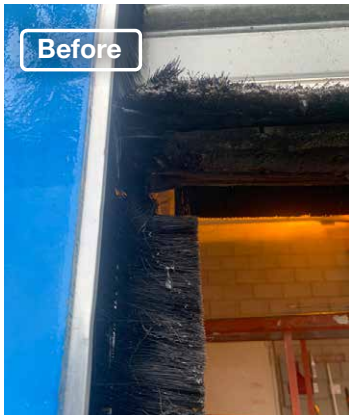
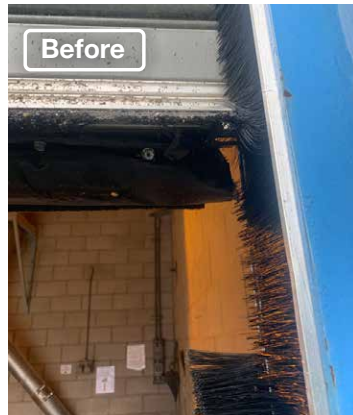
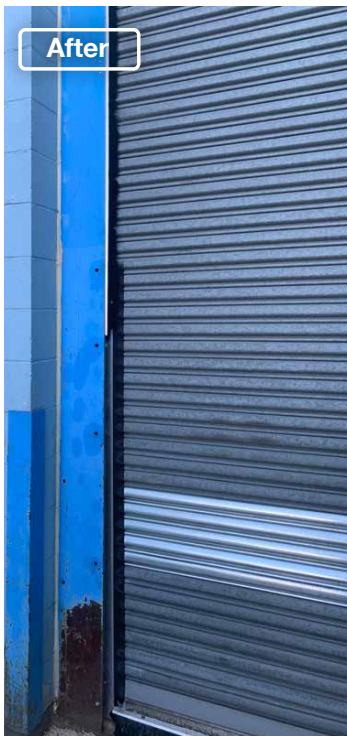
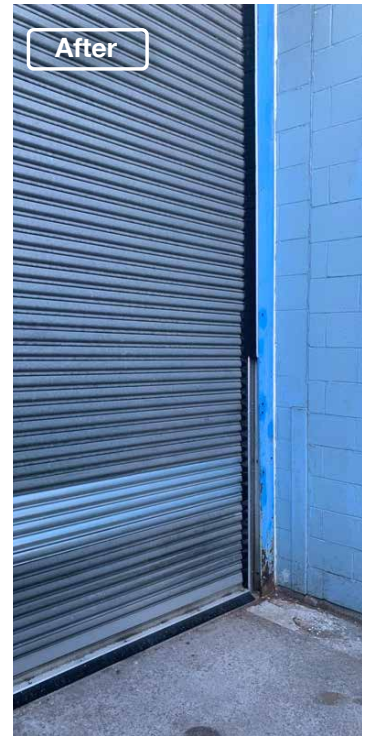
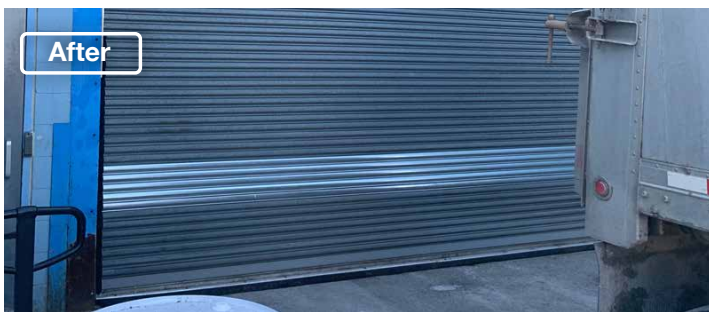
Rodents were getting through the gaps and infiltrating this food manufacturing facility in Cobourg. The old brush and rubber weather was damaged and was leaving gaps up 3", which rodents were getting through.

Northern Dock Systems arrive on site and removed the old weather seal and installed new rodent-proof weather seal. This rodent-proof weather seal has four layers of protection:

The technician installed the perimeter brush weather seal facing the door. However, after testing the rolling steel door, he discovered 2-3" gaps roughly 18" at the bottom of the guides. After inspecting the door, he determined that the weather seal was being pushed from the jamb by rust. So he chisel the rust clear and clamped the guide to the jamb to bolt it in place to eliminate the gap. Finally, after testing the door several more times, he was confident that all the gaps were sealed and that rodents would no longer be able to access the building through this door.
