**Rolling Steel Service Door Replacement
Toronto Hospital**

Toronto, ON

Project Overview

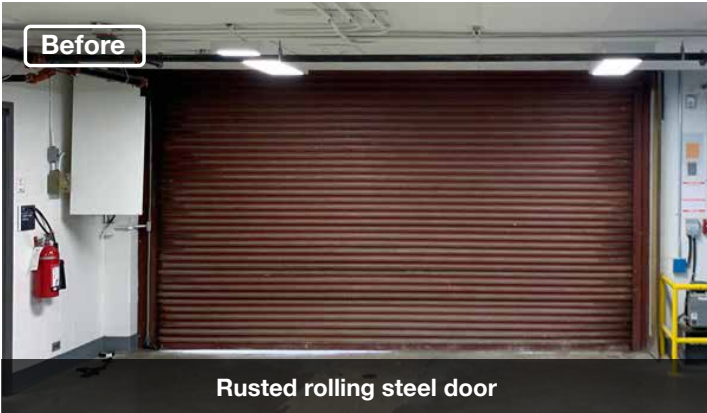
Rusted rolling steel door

The aging rolling steel door at a hospital in Toronto had served its time for 30 years, but it had become rusted and developed holes, rendering it inoperable. As a result, the hospital sought the expertise of Northern Dock Systems to replace it with a state-of-the-art Rolling Steel Service Door.

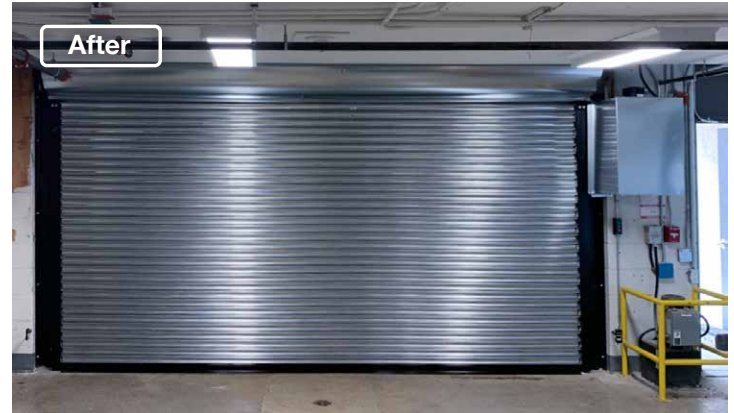
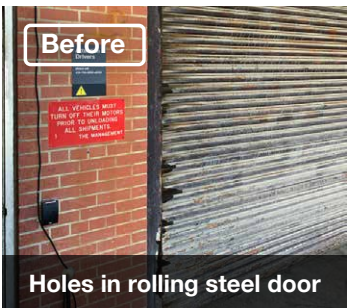
Holes in rolling steel door
