Shoppers Drug Mart

Toronto, ON

Project Overview

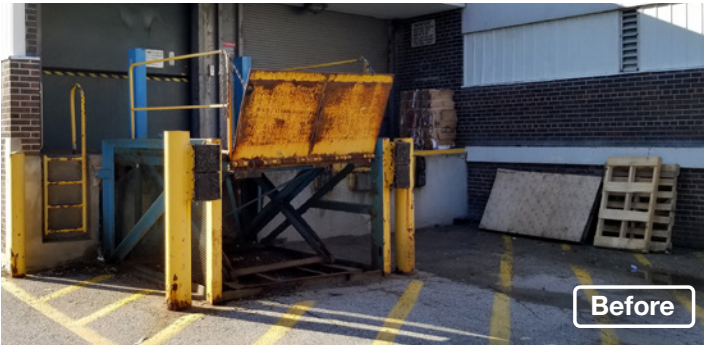
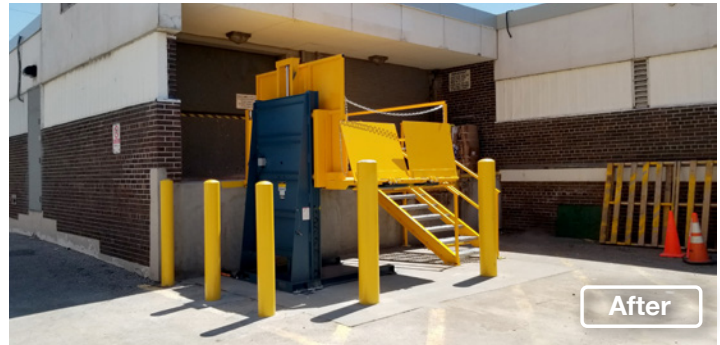
- A Shoppers Drug Mart in Toronto was having issues with their lift table as:
- ✗ The existing lift table was installed on asphalt instead of concrete which resulted in long term issues with the lift table.
 - ✗ The low-lying rollers were rusting and rotting because they were exposed to the elements such as water, slush and snow.
 - ✗ The secondary hinged lip was an unnecessary maintenance expense and safety hazard as forklifts or people could trip over hinges and/or gaps.
 - ✗ The old dock leveler was never removed and had been welded shut. It became a safety issue because it was rusting and crumbling away.
 - ✗ The ladder was an unsafe method for workers to get up onto the dock as it was designed for a swimming pool and not a receiving area.

- ✓ We removed the old dock leveler and bollard system to pour in concrete and installed a bollard system to provide more protection.
- ✓ We installed the mast-guide platform lift. This uniquely designed lift does not have any low-lying rollers and operates on a 100% efficient side cylinder for more reliability.
- ✓ We removed the secondary hinged lip and added a permanent transition plate.
- ✓ We removed the ladder and added proper stairs to ensure the safety of all their workers.
