**Rodent Proof Rolling Steel Door
Manufacturing Plant**

Surrey, BC

Project Overview

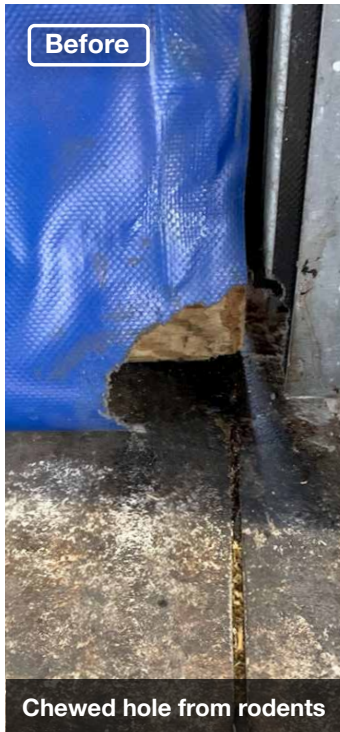
Before

Chewed hole from rodents

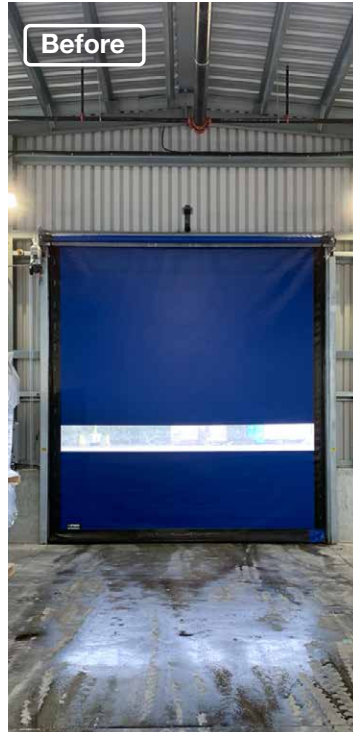
Before

This manufacturing plant in Surrey BC had issues with rodents entering the facility. Rodents have chewed through the bottom of their high-speed vinyl fabric door. They had tried rodent-proofing this door in the past but had no success.

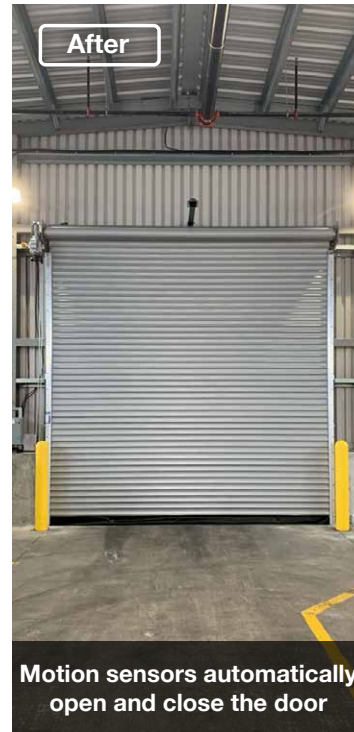
Motion sensors automatically open and close the door

They reached out to Northern Dock Systems for a solution. After talking with the manufacturing plant, we realized that it would be best to remove the fabric door and replace it with a [Hormann Steel Ranger rolling steel door](#). Rodents would be unable to chew through the rolling steel door.

In addition, we added automatic open and close motion sensors to prevent the door from accidentally being left open for pests to enter the manufacturing facility. The [Falcon motion sensors](#) can sense incoming traffic to open the door and have a timer to close the door within 30 seconds of it being open.

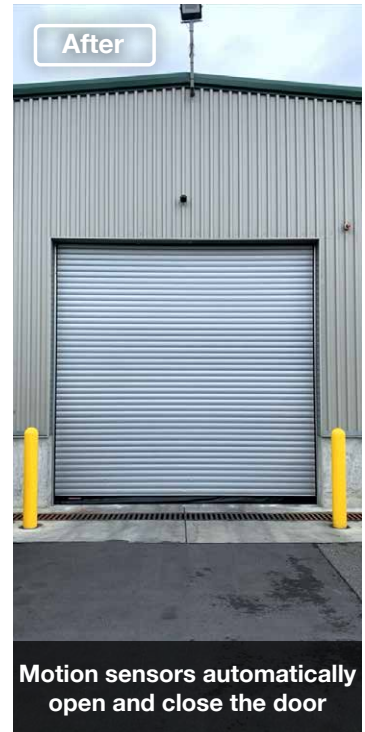
After

Motion sensors automatically open and close the door

In order to prevent the door from accidentally closing on vehicles, forklifts or people, the Steel Ranger comes standard with a built-in light curtain. It has an 8'0" high light grid with infrared beams every 1.75". If a beam is interrupted, it will automatically reverse the door to protect people, vehicles and products from making contact with the door.
