## Aluminum Doors with Polycarbonate Panels

Lactalis Canada

Calgary, AB

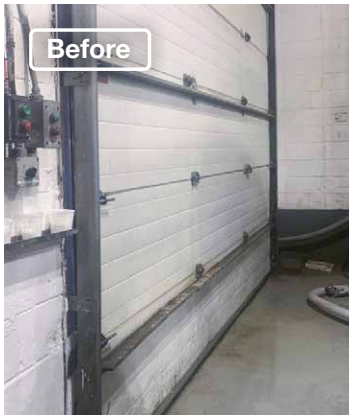
Before

Lactalis Canada in Calgary had problems with their existing doors in their wash down area. The bottom three sections of the old sectional overhead door had slowly absorbed water from the multiple wash downs. As a result of the absorbed moisture, these panels were twice their normal weight. The extra weight was causing premature wear and tear of the electric door operators. Furthermore, because of the moisture and lack of drainage, ice would build up and the doors would occasionally freeze to the ground in the winter.

Lactalis Canada contacted Northern Dock Systems for an overhead door solution for their wash-down area. Our technicians replaced the waterlogged and heavy existing doors with lightweight Aluminum Overhead Doors with Polycarbonate Panels. These polycarbonate doors will not absorb water like insulated steel sectional doors do. Making it a great solution for wash down areas.

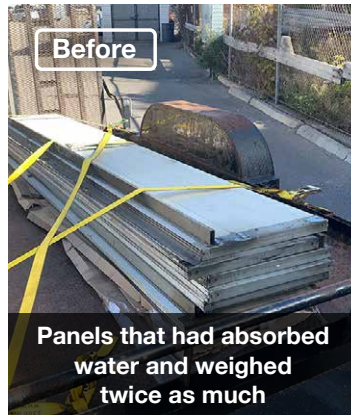
Before

Panels that had absorbed water and weighed twice as much
