Dock Lift Table Replacement CSA Group

Etobicoke ON

Project Overview

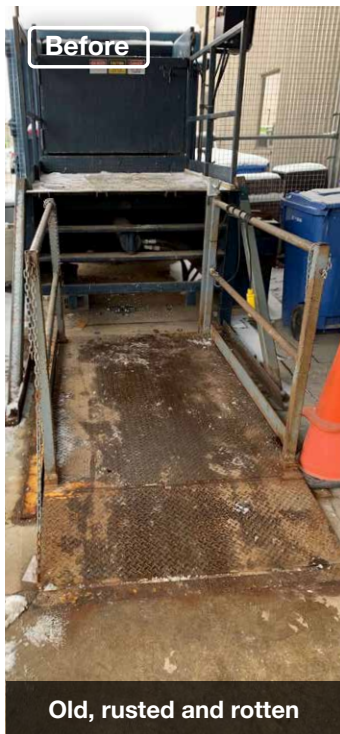
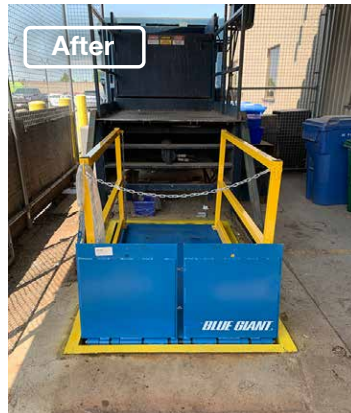
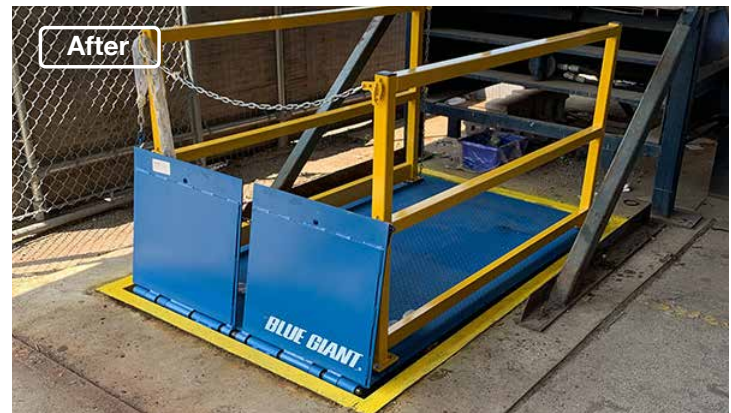
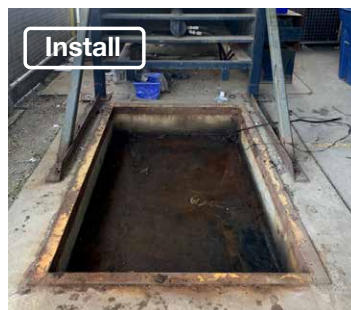
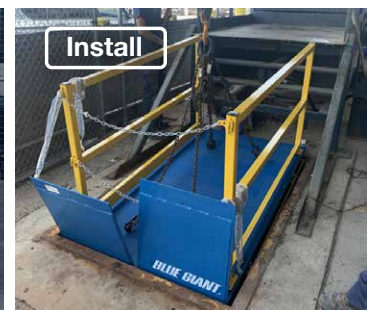
The current dock lift table at this pharmaceutical facility in Etobicoke was old, rusted and the frame was rotting. Additionally, the existing pump was unreliable as the dock lift table was having problems travelling up or down.

They reached out to Northern Dock Systems to remove and replace their dock lift table. We installed a new [Blue Giant LoMaster Stationary Dock Lift table](#). This new dock lift has a much cleaner and tidier appearance. With its new anti-slip powder-coated deck it will be rust-resistant for years to come.

Additionally to the deck being protected from rust, the hydraulic cylinders are completely sealed and vented back to the hydraulic tank to be weather resistant for outdoor use.

Moreover, the split lip rather than a single lip design will make it easier on employee's backs when lifting and lowering the lip

In addition, this dock lift table comes with an OSHA-compliant 42" high bolt-on steel guardrail and perimeter personnel restraint chains on both open sides to improve safety.

Furthermore, the new pump with hand-held 24V push button up/down controls will make it easy, more reliable and safer to use.

Finally, our technicians finished off the installation by painting and resealing the curb angles around the dock lift table pit to improve safety and protect against rust.
