HingeMaster Extreme Dock Shelter & Overhead Door Warehouse

Whitby, ON

Project Overview

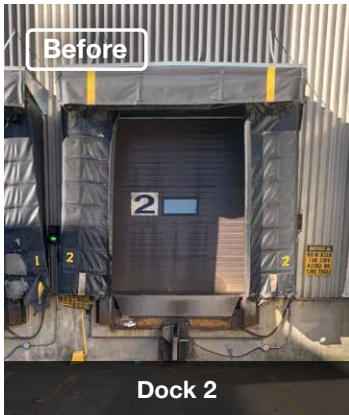
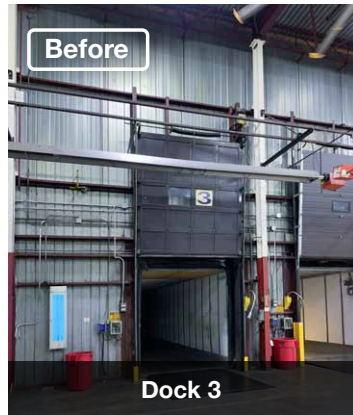
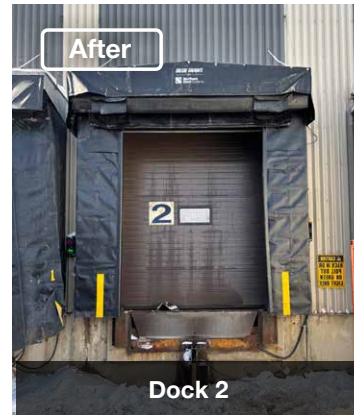
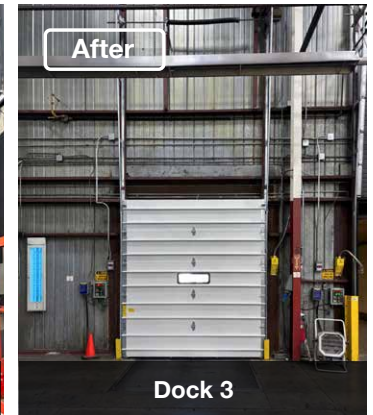
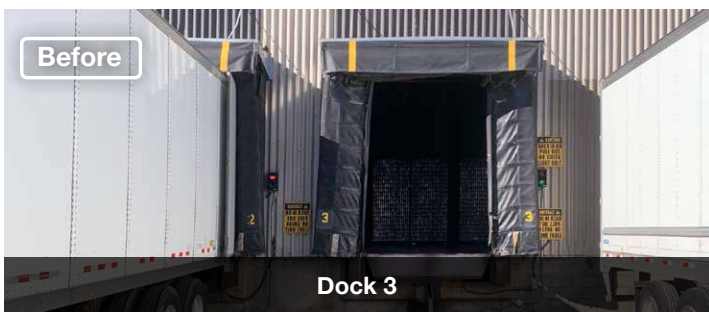
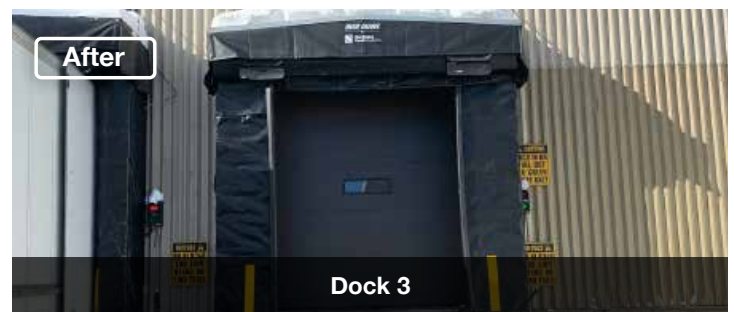
In a busy warehouse in Whitby, the team faced numerous issues with their dock and shelter setup. The old seals weren't sealing properly, causing drafts and inefficiencies. The inflatable top header airbag frequently broke, leading to constant repairs and downtime. Additionally, the old wooden overhead door allowed cold air to enter, making the interior uncomfortable and less energy-efficient.

To address these problems, the warehouse contacted Northern Dock Systems for an upgrade. We replaced the old seals with new [Blue Giant HingeMaster Extreme Dock Shelters](#). These new shelters created a tight seal around trailers without the need for airbags, reducing repairs and improving efficiency. The shelters featured durable vinyl, a strong steel frame with snow load supports, J-hooks for a zero-daylight seal, and a built-in [Rain Shroud](#) to divert water and snow.

The installation process was thorough. After disposing of the old inflatable dock shelters, the new Hingemaster Extreme shelters were installed on docks 2 and 3 using spray foam and caulking, ensuring a perfect seal against the corrugated siding wall. Additionally, a new [Insulated Sectional Steel Overhead Door](#) was installed at position 3, blocking cold air and improving the internal climate. The existing jackshaft motor was reused and reconnected to the new door.
